# Bateman Inspections

Confidential - Property Inspection Report - Confidential

123 Sample Report, Bowmanville, Ont

Inspection prepared for: Sample Report  
Date of Inspection: 1/17/2013 Time: 9:00 am  
Age of Home: 11 years Size: 2,400 sq. ft.  
Weather: Sunny

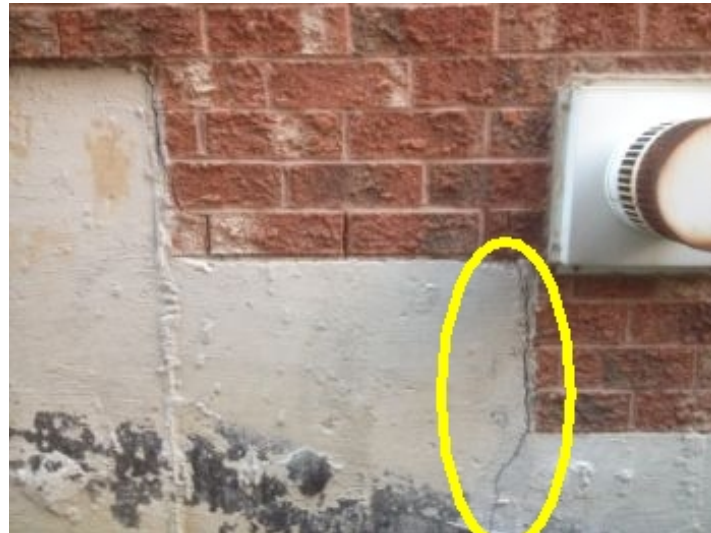
- The house siding appeared in serviceable condition, at time of inspection.
- Some minor cracks from settling noted

Some minor cracks from settling noted

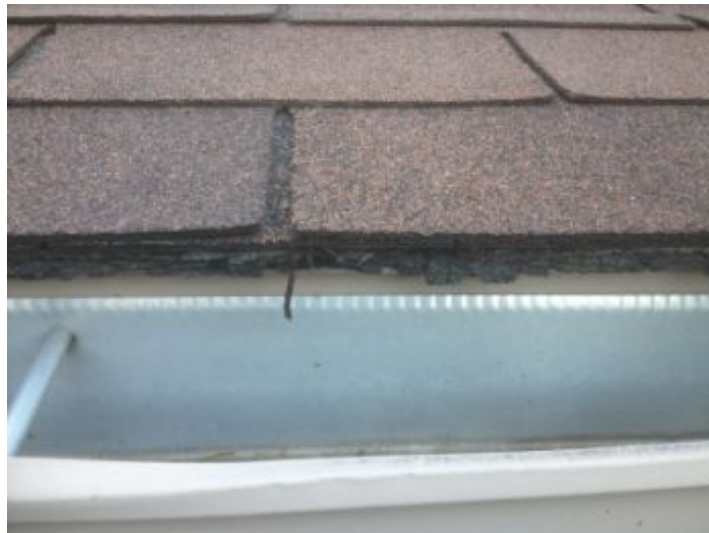
- Roof appeared serviceable with no deficiencies noted at time of inspection. No prediction of future performance or warranties can be offered.

2 visible coverings

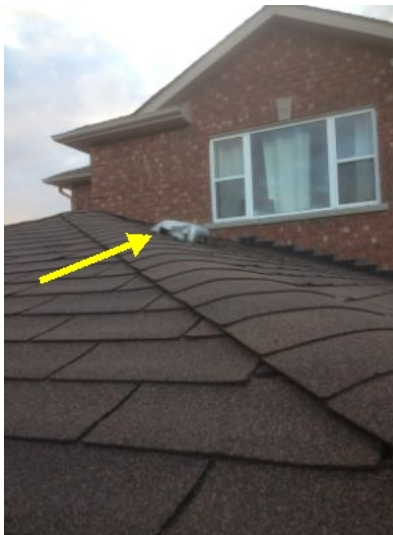
Vent over the garage was dented. Recommend replacing by roofing contractor.

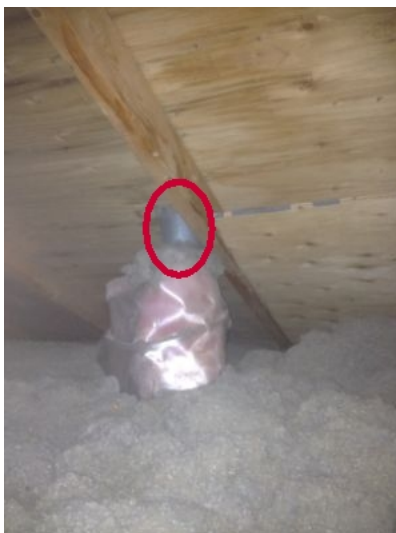
- Bathroom vent not fully insulated. Recommend insulating to prevent moisture / condensation forming.

Bathroom vent not fully insulated. Recommend insulating to prevent moisture / condensation forming.

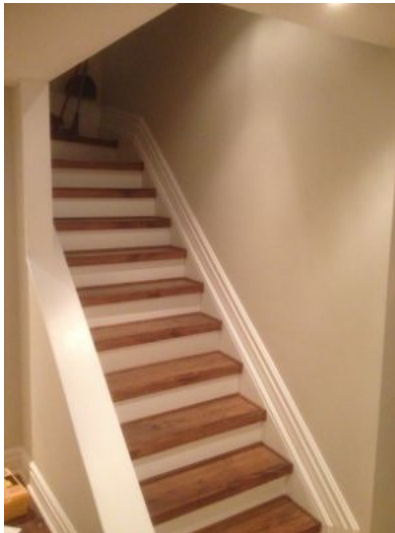
**Observations:**  
 • Recommend hand rails leading to basement.

Recommend hand rails leading to basement.

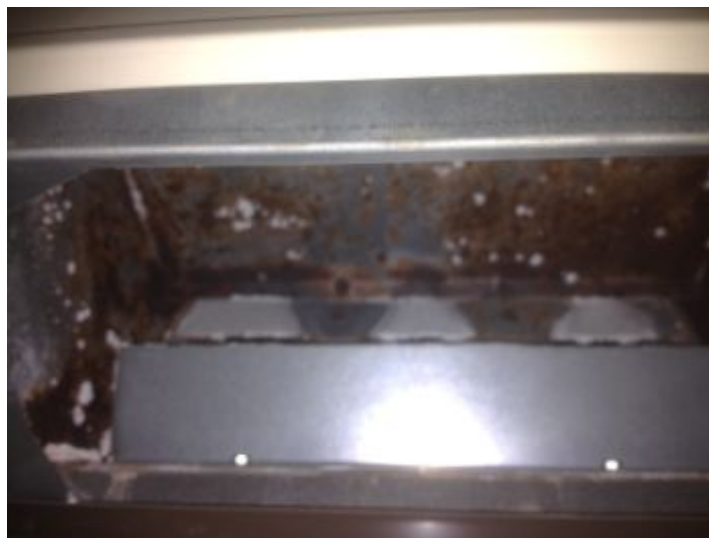
- No deficiencies observed.
- IMPROVE: The furnace is dirty and there are no records of prior service. Recommend an HVAC contractor perform a system Clean-and-Check. HVAC systems require yearly maintenance.
- Annual/seasonal HVAC service contract highly recommended.
- Due to presence of rust, scale, and some debris in this furnace, a professional cleaning and service review by a licensed HVAC contractor is highly advised to ensure proper and safe operation of this unit. Inspection for holes and/or cracks in heat exchanger is not within the scope of this inspection and should be performed by a HVAC contractor prior to ensure the proper and safe operation of this system.

Due to presence of rust, scale, and some debris in this furnace, a professional cleaning and service review by a licensed HVAC contractor is highly advised to ensure proper and safe operation of this unit. Inspection for holes and/or cracks in heat exchanger is not within the scope of this inspection and should be performed by a HVAC contractor prior to ensure the proper and safe operation of this system.

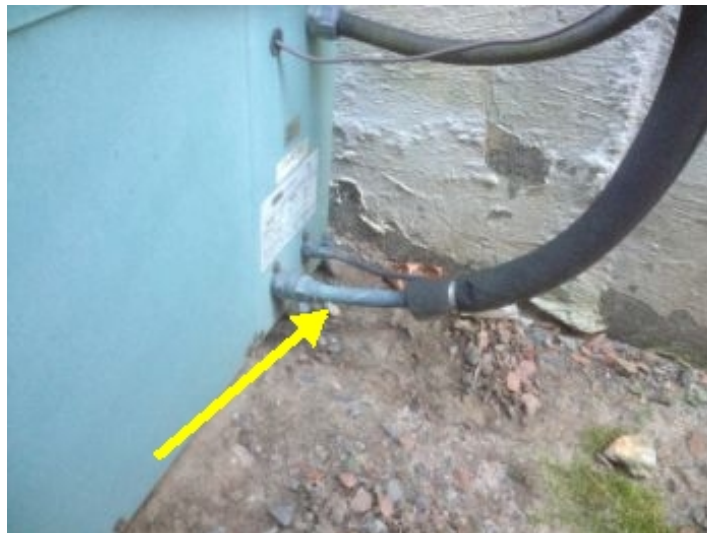
**Observations:**  
 • A/C Unit or Heat Pump not operated in the cooling mode (see Limitations). The ability of the cooling system to perform its normally intended function and operation could not be determined.  
 • Annual/Seasonal professional HVAC inspection and cleaning service contract is recommended.  
 • The insulation is missing or damaged at exterior refrigerant line.

The insulation is missing or damaged at exterior refrigerant line.

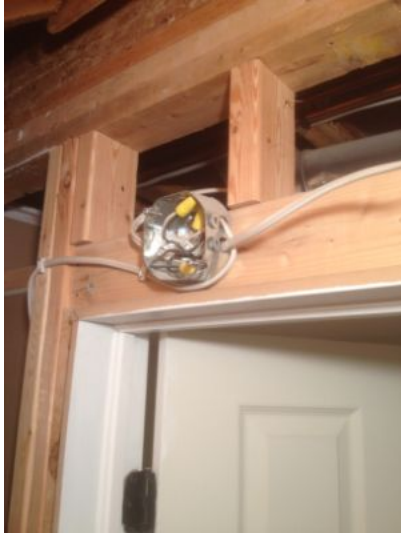
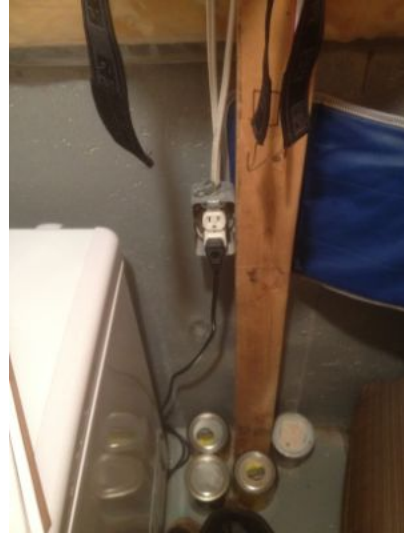
- A representative number of receptacles, switches and lights were tested and are generally serviceable, unless otherwise noted.
- **SAFETY CONCERN: Missing cover plates at multiple outlets and light switches. Repair as needed.**

SAFETY CONCERN: Missing cover plates at multiple outlets and light switches. Repair as needed.

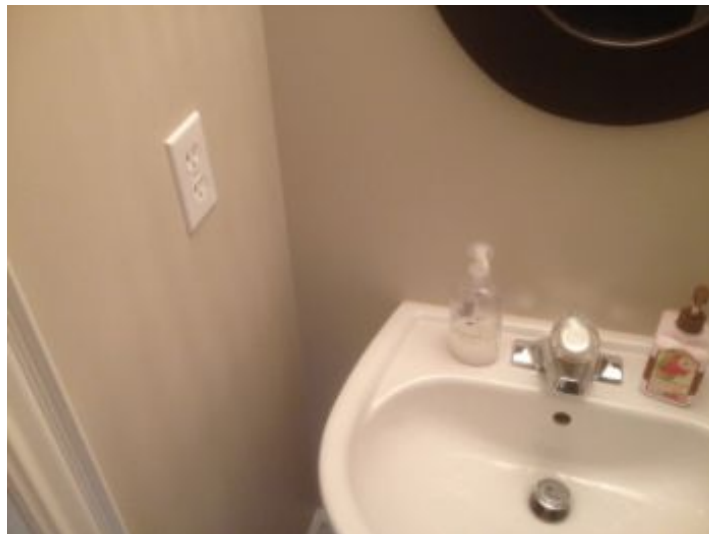
- Test GFCIs monthly to ensure proper operation.
- **There is no GFCI protection at hall bath**

There is no GFCI protection at hall bath

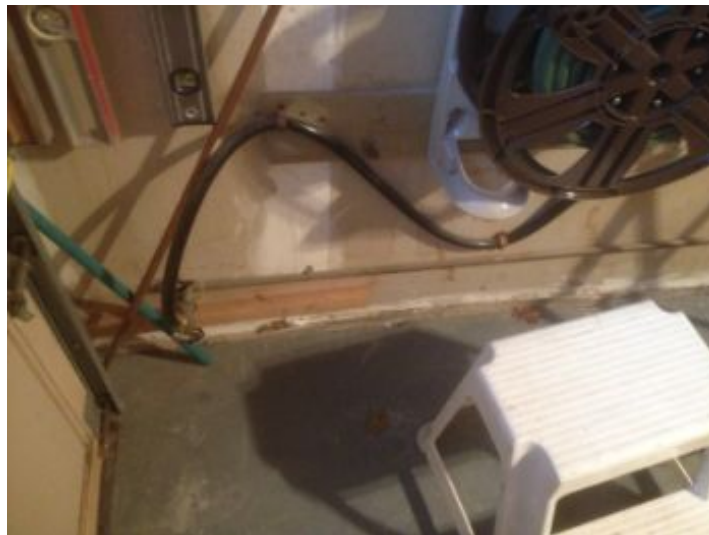
- No deficiencies observed at the visible portions of the supply piping.
- Most of the piping is concealed and cannot be identified.
- Insulation advised for pipes at unheated areas.

Insulation advised for pipes at unheated areas.

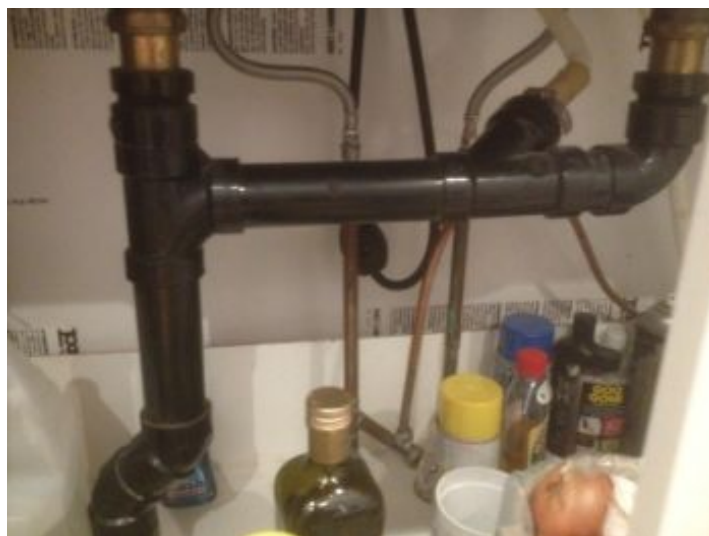
- Water was run through the fixtures and drains. Functional drainage was observed.
- No drain trap observed in hall bath

No drain trap observed in hall bath
